**A PARCEL PROPERTY LAND, TWO-
STORY & BUILT ON DWELLINGS,
SITUATED AT HOOIBERG 92-U**

APPRAISAL REPORT 2023_090

MARCH 23, 2023

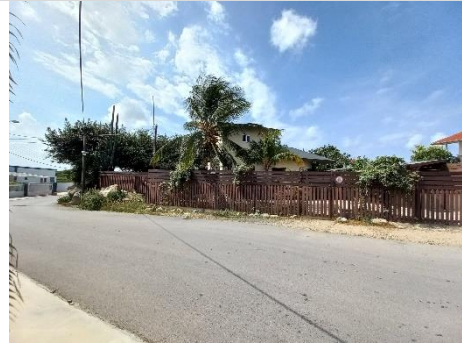
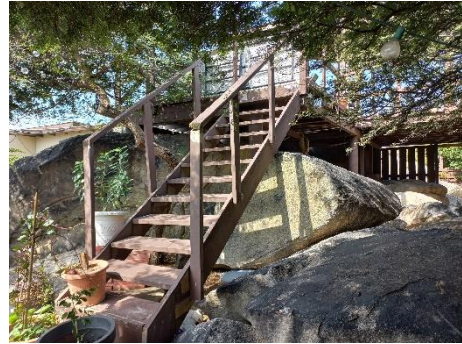
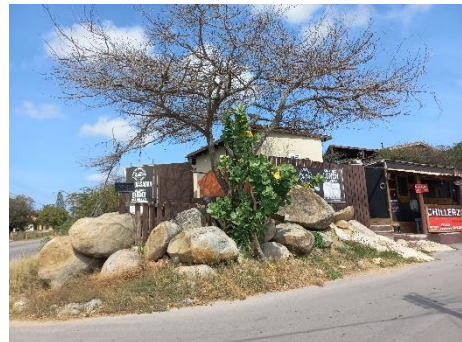
- A profound inspection of the premises was carried out, both inside and outside of house, snack shack and 2 apartments
- The dwellings show several visible defects and the overall condition of maintenance is moderate to insufficient

MAINTENANCE TABLE	N	G	S	M	I	P	U	Clarification
Foundation			X					
Floors			X					
Walls			X	X				Cracks and non-structural cracks in walls require repair (A, G) Water damaged walls require replacement(G)
Roof				X	X			Sign of water damage roof covering require repair and/or replacement (B,C,D,F,G,H)
Frames, windows and doors			X	X				Door glass require replacement(G) few windows and doors require repair or replacement (A+G)
Floor and wall tiles			X					Cracked/broken tiles require replacement
Ceiling			X		X		X	Several areas no ceiling Few areas ceiling require replacement (F)
Painting			X	X				Several areas interior walls require repainting
Kitchen				X				Kitchen cabinets require adjustment (A+G) Countertop require replacement (G)
Bathroom fixtures			X					
Plumbing			X					
Electrical installation			X					
Hardscape and/or landscaping			X					
Fencing			X					
<p><i>N: new (within 1 year after completion)</i> <i>G: good = as new</i> <i>S: sufficient = no maintenance excepted within 2 years</i> <i>M: moderate = maintenance excepted within 2 years (clarification)</i> <i>I: insufficient = maintenance / repair necessary (clarification)</i> <i>P: poor = replacement necessary (clarification)</i> <i>U: unfinished</i></p>
