**A PARCEL PROPERTY LAND AND
BUILT ON DWELLING, SITUATED AT
MISSOURISTRAAT 2**

APPRAISAL REPORT 2021_005

JANUARY 6, 2021

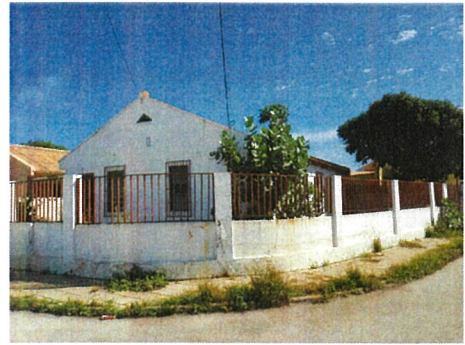
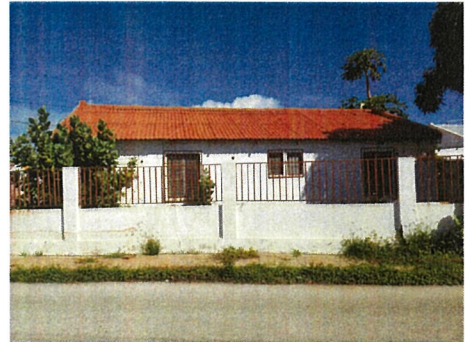
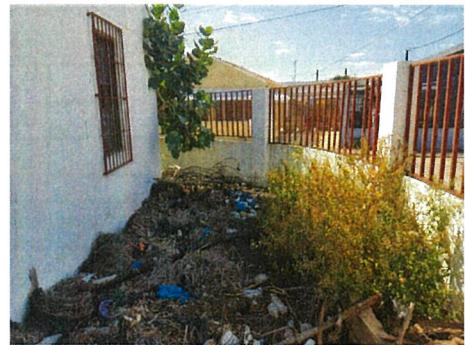
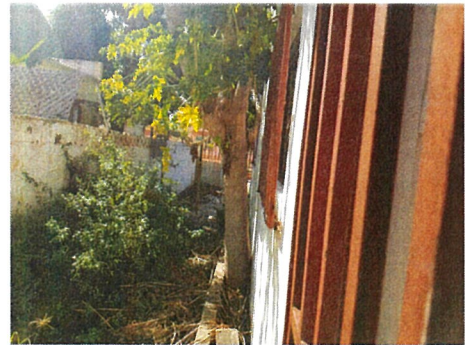
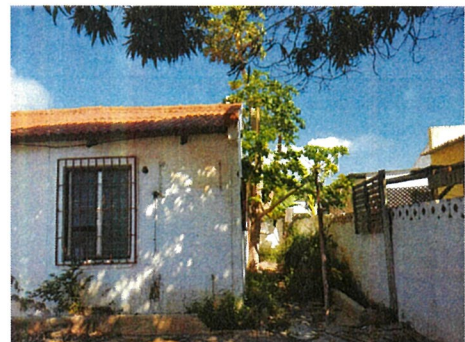
A profound inspection of the premises was carried out, both inside and outside; the house is not occupied, showing several visible defects. The overall condition of maintenance of the house is moderate.

- *the asbestos roof is intact, but would eventually require replacement*
- *there are several cracks in the walls*
- *the aluminum windows and the bathroom fixtures will also need to be replaced within 2 years*
- *There is no kitchen and one toilet is missing*
- *Several areas of the ceiling are missing and need maintenance*
- *The complete painting required immediate maintenance*
- *Exterior door require replacement*
- *Metal fencing between columns & metal entrance doors require maintenance and replacement*
