**A PARCEL PROPERTY LAND AND
BUILT ON DWELLING, SITUATED AT
PONTON 70-L**

“DRIVE BY” APPRAISAL REPORT 2022_231

AUGUST 30, 2022

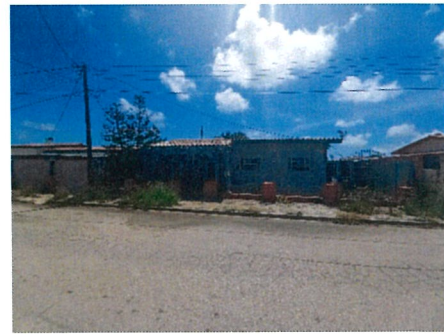
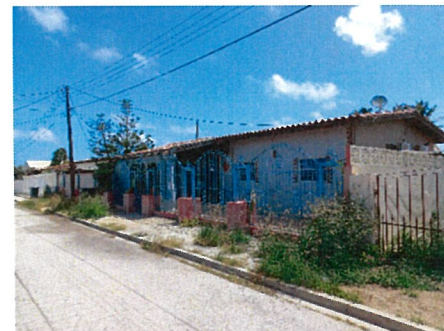
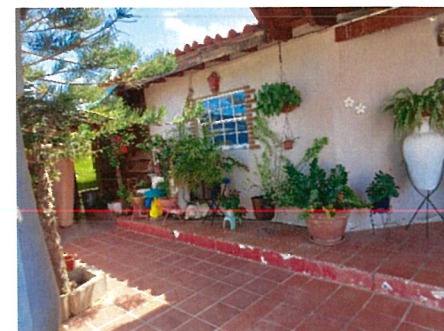
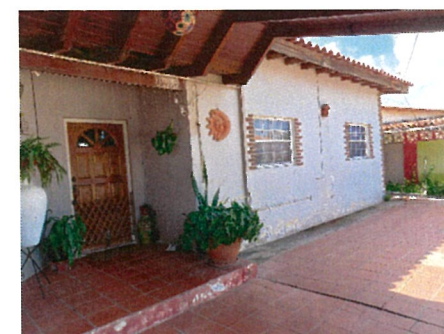
- The premises were inspected on the outside
- Show several visible defects and the overall condition of maintenance, limited to the exterior, is moderate
- The house appears to be occupied and has several visible defects

- *The dwelling overall requires maintenance*
 - Based on the maintenance condition on the outside, a similar condition is assumed for the inside
1. *Multiplex boarding of the roof at the porch require replacement*
 2. *The exterior side of the dwelling requires repainting*
 3. *Several tiled concrete floor require replacement*
