FAÇADE APPRAISAL REPORT.

Concerning a parcel of long lease land cadastral known as parcel 1-C-89, located at Pampunastraat 15-G, with the concrete block house and apartment in name of _____ and on request of **management of Fundacion Cas Pa Comunidad Arubano (F.C.C.A).**

Appraisal report:

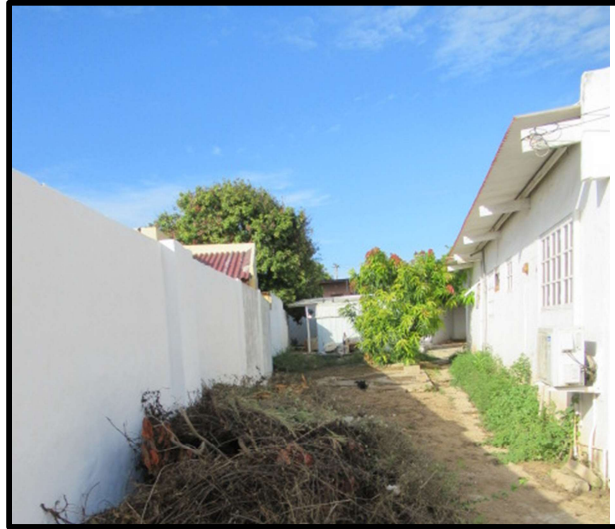
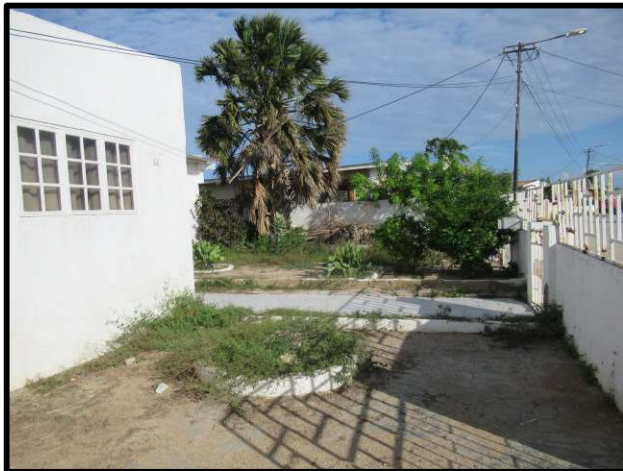
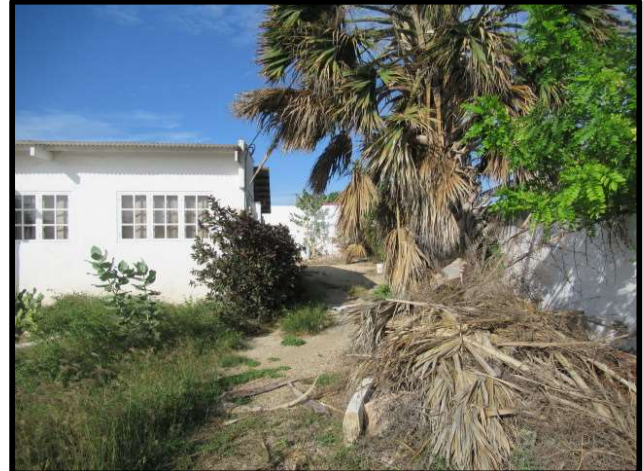
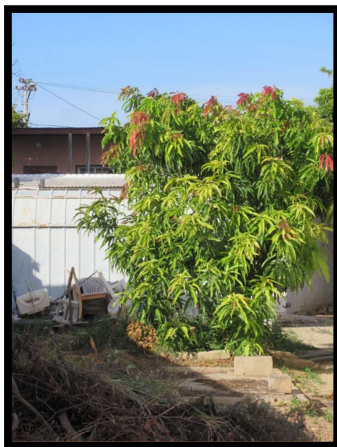
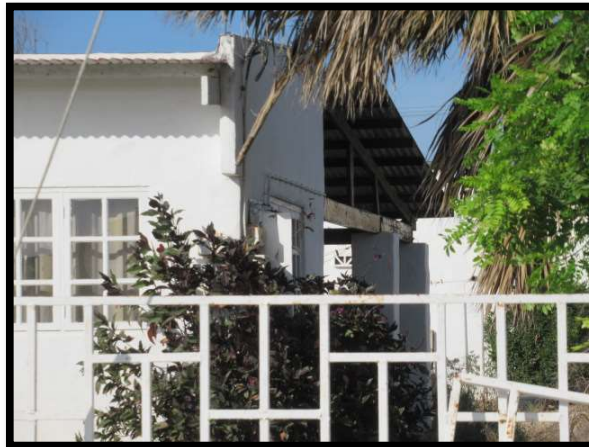
The house and fence on the South border are in a poor maintenance condition. Cracks were observed in the exterior walls of the house.

Exterior of the house at Pampunastraat 15-G.

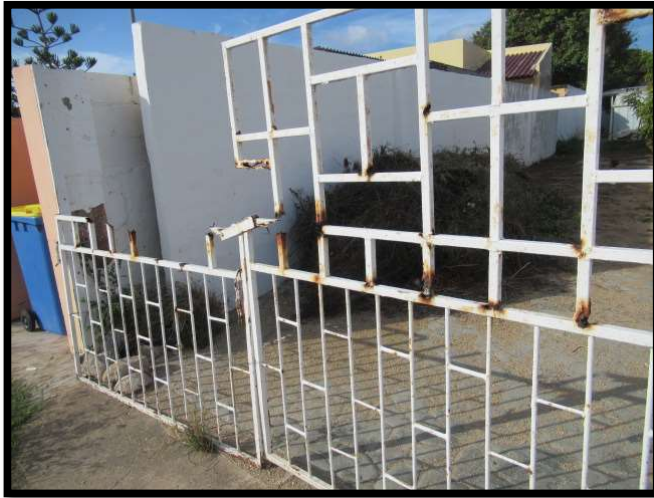
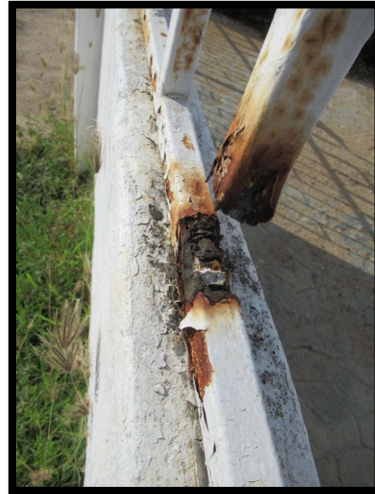
The parcel of long lease land is fenced on the South border with a 1.0m high masonry wall in combination with reinforced concrete columns. On the masonry wall steel railings are built up to 1.60m height. Steel swing gates are installed. **Note: The steel railing and gates are in a poor maintenance condition.** All other borders are fenced with a 1.60m – 2.20m masonry fence in combination with concrete columns. The fence is partly plastered and painted.

Condition of the steel fence gates and railing at Pampunastraat 15-G.

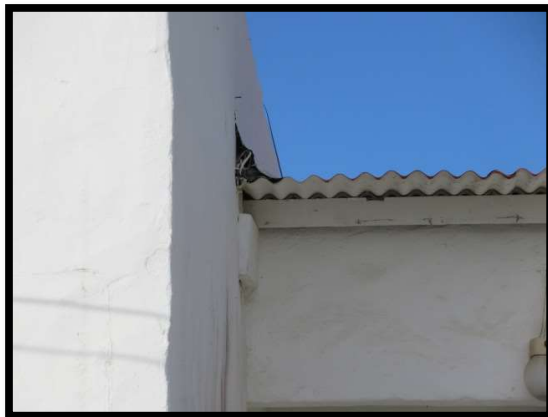
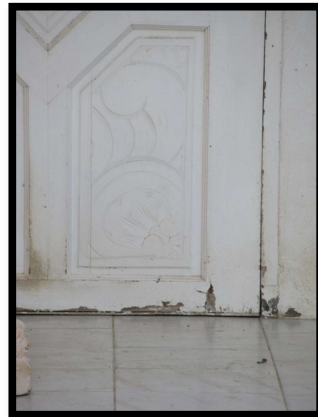
Roofing and entrance door condition at Pampunastraat 15-G.

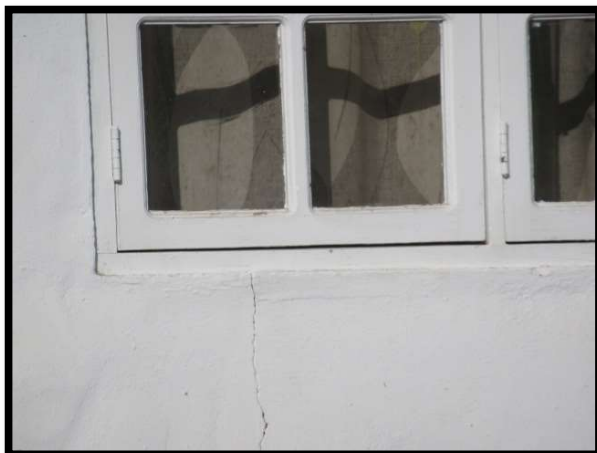
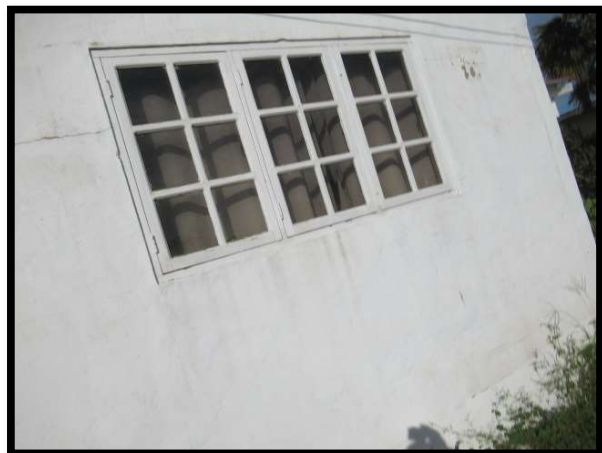
Some cracks were observed in the exterior walls.

Crack in exterior wall at Pampunastraat 15-G.
