**A PARCEL LONG LEASE LAND AND
BUILT ON DWELLING,
SITUATED AT HOOIBERG 17-A**

APPRAISAL REPORT 2024_258

JUNE 11, 2024

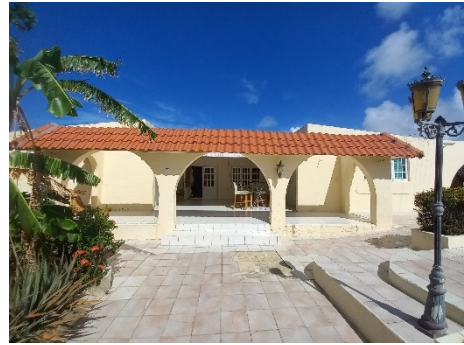
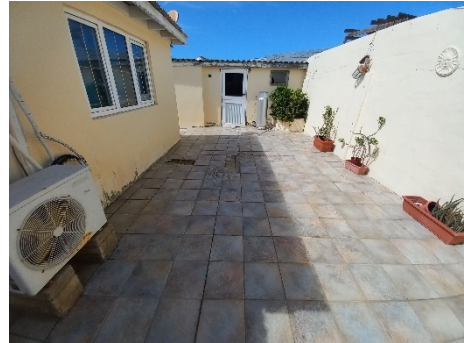
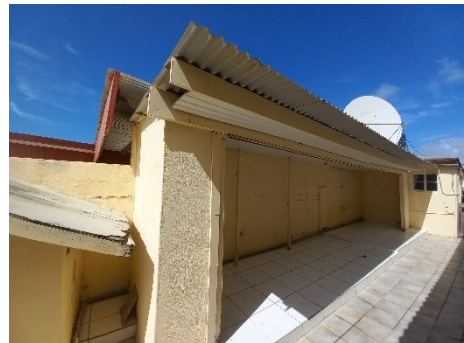
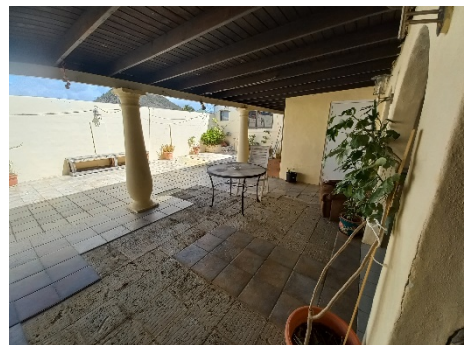
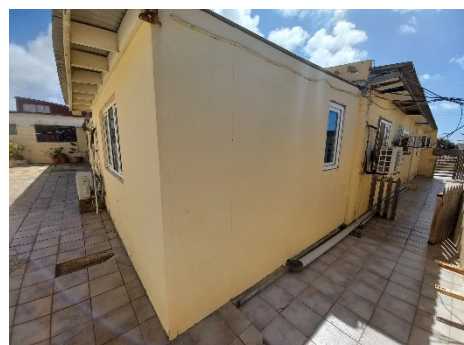
- A profound inspection of the premises was carried out, both inside and outside
- The dwelling shows many visible defects and the overall condition of maintenance is moderate to insufficient

MAINTENANCE TABLE	N	G	S	M	I	P	U	Clarification
Foundation			X					
Floors			X					
Walls			X	X	X			Several cracks in walls around the dwelling Several concrete columns and ring beam are degraded Several areas of the wall require replaster
Roof			X	X	X			Several areas of the roof show signs of water damage Several PVC slat at the roof overhang are missing Several areas of the roof at the doghouse is damaged and show signs of water damage Inspection roof structure recommended!
Frames, windows and doors				X	X			Several exterior and interior wooden doors damaged Several windows rotten Several windows are damaged and broken
Floor and wall tiles			X	X	X	X		Loose, broken and missing floor tiles Several vinyl floor tiles are missing and broken Wallpaper require replacement
Ceiling			X	X	X			Several area of the ceiling is damaged Several areas of the ceiling have sagged Several soft grid panels are missing and require replacement

Painting				X	X			Several areas of the exterior and interior walls, wooden windows, kitchen cabinets, face board fence wall and entrance gates
Kitchen			X	X	X			Many cracked tiles on the countertop and missing tiles at the bottom of the cabinets Cabinets doors require adjustment Cabinets missing
Bathroom fixtures			X		X			Inspection and / or replace at the workshop
Plumbing			X					
Electrical installation			X					
Hardscape and/or landscaping				X	X			Cracked and missing floor tiles
Fencing			X	X				Cracks in fence walls and columns
<p><i>N: new (within 1 year after completion)</i> <i>G: good = as new</i> <i>S: sufficient = no maintenance excepted within 2 years</i> <i>M: moderate = maintenance excepted within 2 years (clarification)</i> <i>I: insufficient = maintenance / repair necessary (clarification)</i> <i>P: poor = replacement necessary (clarification)</i> <i>U: unfinished</i></p>
