FAÇADE APPRAISAL REPORT.

Concerning a parcel of long lease land cadastral known as parcel 1-C-89, located at Pampunastraat 15-G, with the concrete block house and apartment in name of _____ and on request of **management of Fundacion Cas Pa Comunidad Arubano (F.C.C.A).**

Appraisal report:

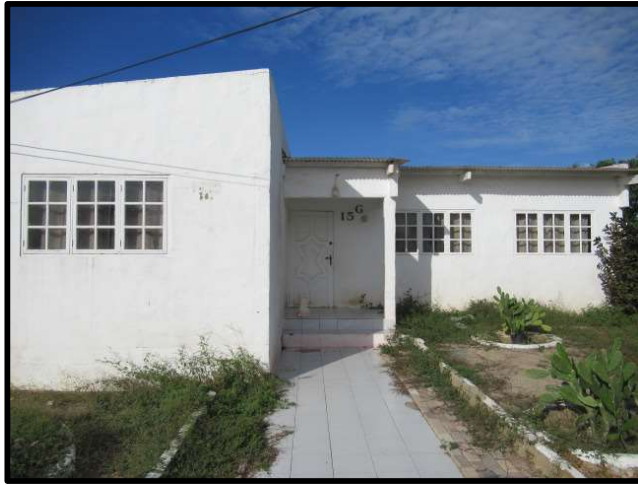
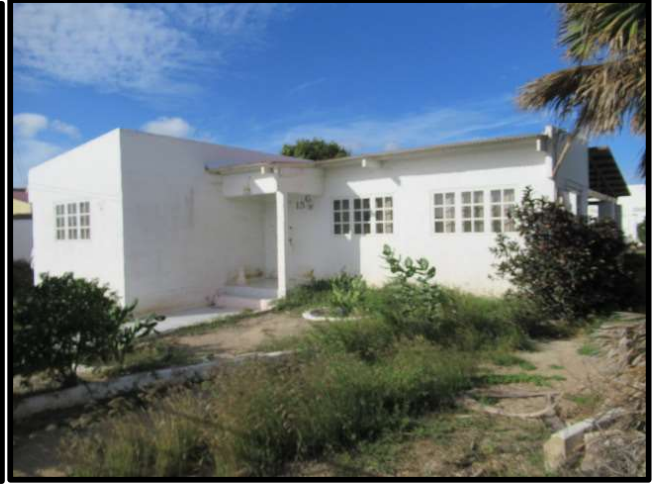
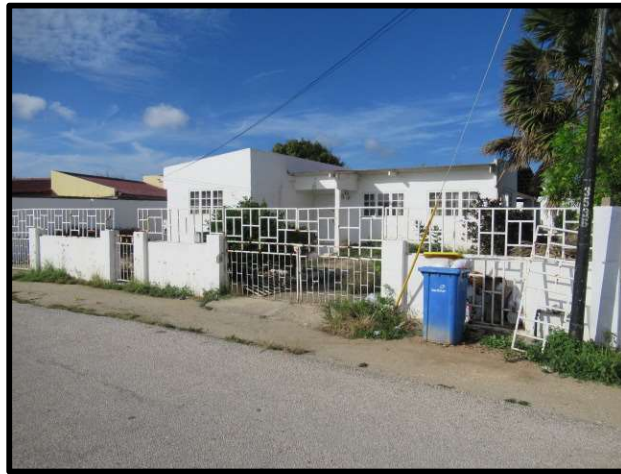
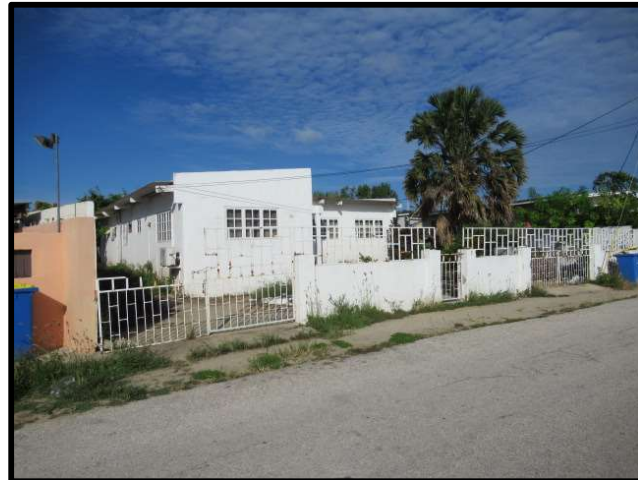
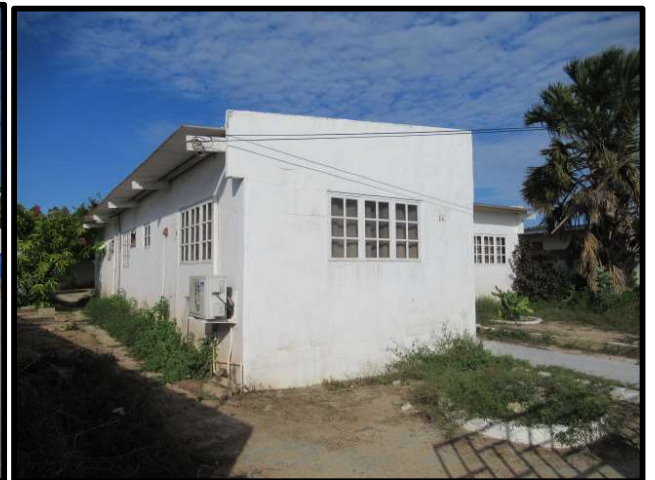
Exterior front of the concrete block house at Pampunastraat 15-G.

The house and fence on the South border are in a poor maintenance condition. Cracks were observed in the exterior walls of the house.
